Slope Stability Problems Along the Main Roads in the Kurdistan Region

Varoujan K. Sissakian¹, Hassan O. Omer²

ABSTRACT

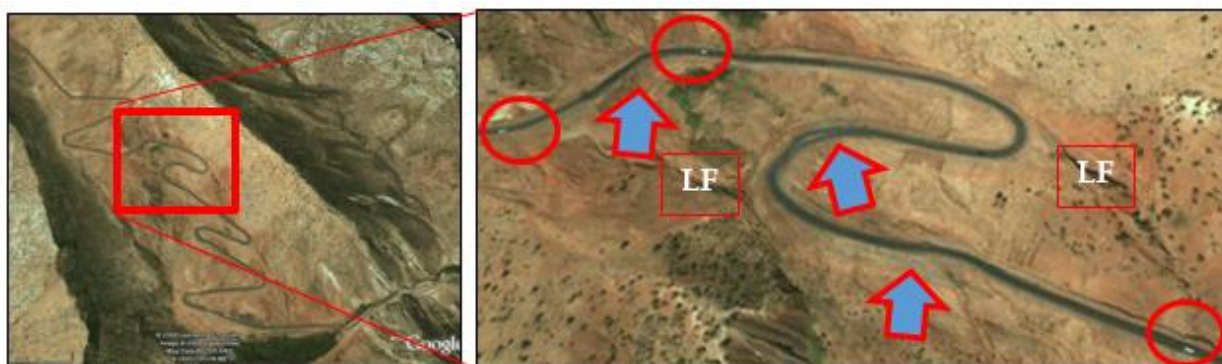
ward. The authors have recognized that the majority of the roads run in soft rocks, which are mainly claystone (Fig. 1) and some sandstone. This is attributed to the fact that the soft rocks are easily excavated; accordingly, the construction of the road will be faster and the cost will be less. The consequences; however, are mainly causing failures of different types along the slopes. It is worth mentioning that the majority of those soft rocks are overlain by hard carbonate rocks, which may slide down when the underlying soft rocks are excavated as road cuts (Fig.1), which means hazardous zones. But, this doesn't mean that no roads are constructed in rocky terrain and all road cuts are stable. A good example is large landslides along Dukan – Surdash road, which runs in a rocky terrain and some of the slopes of the road cuts are unstable (Fig. 2).

Fig (1) : Google Earth image showing a road cut in red claystone, between Zahko and Kani Masi. Note the damaged parts of the road (Arrows) and large fractures (LF). Cars are encircled in red for scale

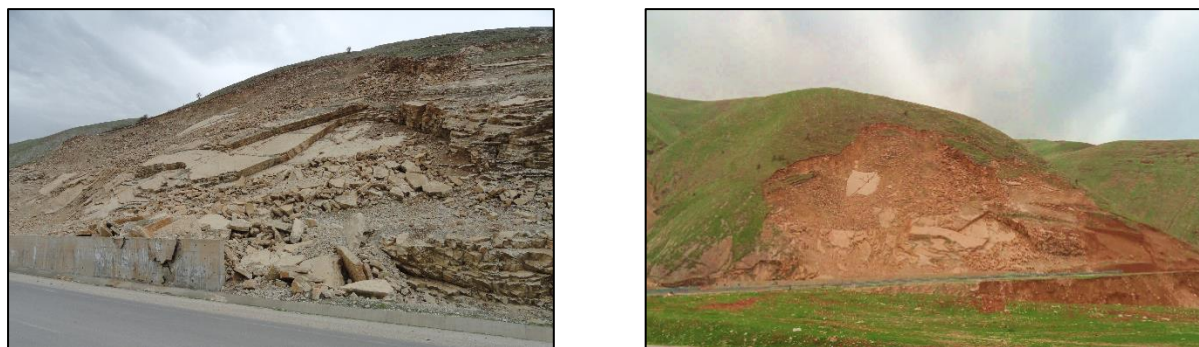
Fig (2) : Two landslides in rocky terrain along the main Dukan – Surdash road.

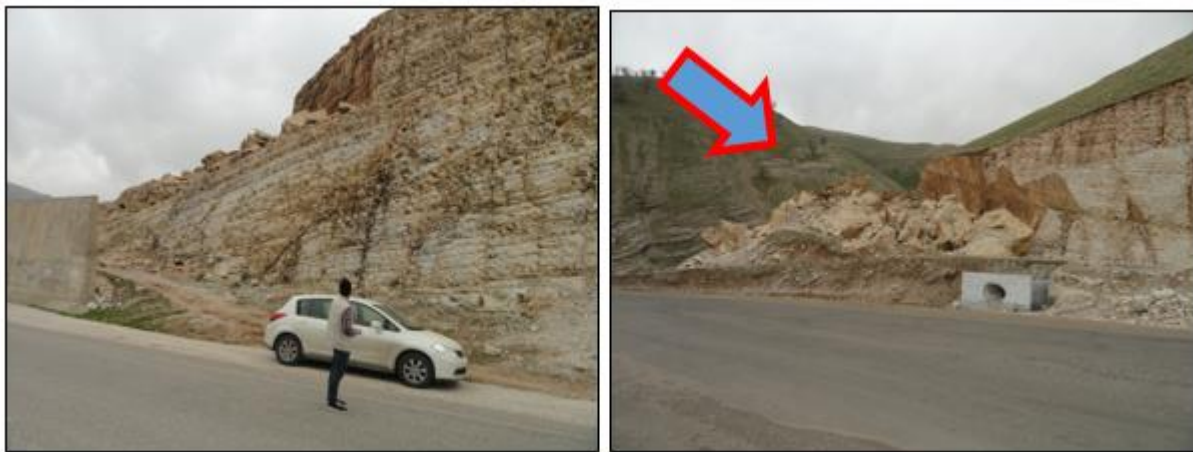
excavations of road cuts and/ or blasting is one of the main objectives of the cost (Ghajar et al., 2013). The cost will increase with increasing the amounts of the excavated and/ or blasted materials. Therefore, the road cut slope is a function of cost; accordingly, the majority of the road cuts; unfortunately, are designed to be almost vertical or in very acute slope angle (Fig. 3).

Fig (3) : Road cut along Dukan – Surdash main road. Left) Vertical road cut, but still is stable, Right) The same road cut and the same locality, but the slope failed due to the interference of the road cut direction and the attitudes of the bedding and jointing

The vertical slope; however, would be stable if studied relevantly to indicate: **1.**The relevant road cut direction, **2.**Direction and dip amount of the rocks (if the road cut is in rocks, **3.**Mechanical properties of the soil (if the road cut is soil), and **4.**The height of the road cut. These parameters are again effecting positively on the cost, when relevantly studied.

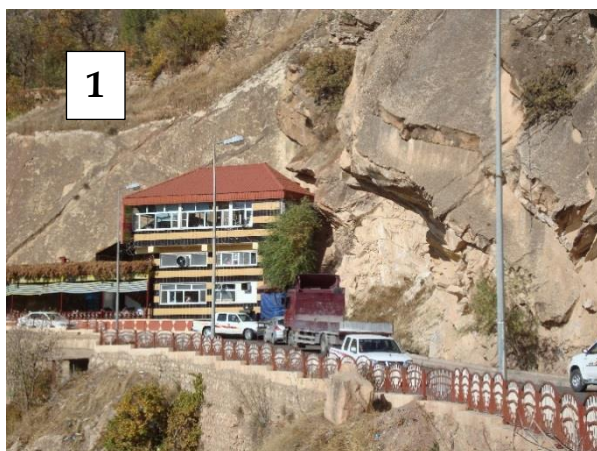
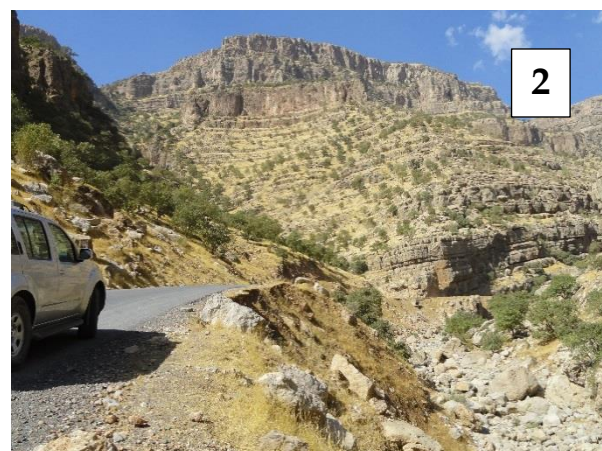
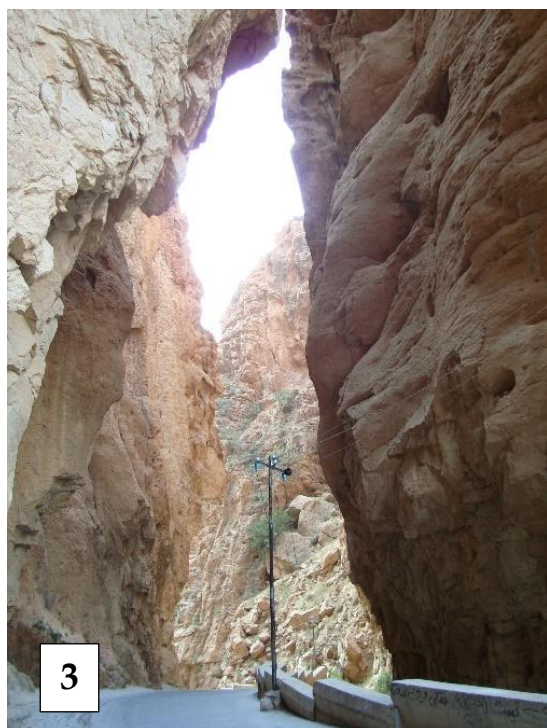
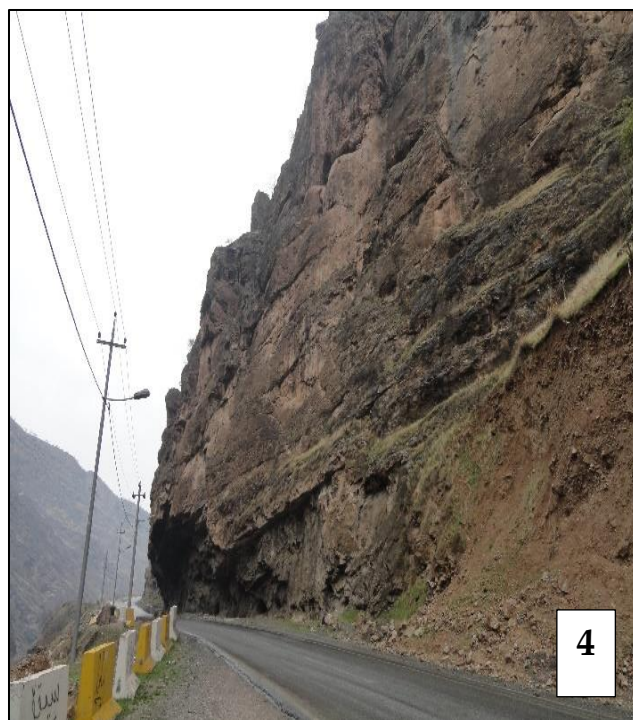
In the Kurdistan Region, some of the road paths run through main gullies and/ or valleys. Certainly, they are easily constructed through those natural paths, which cross usually very high mountains; however, they are not safe enough. Good examples are Gulley Ali Beg, Gulley Zanta, Gulley Bekhme, Gulley Shamdinan, Gulley Amadia ...etc. (Fig. 4).

Fig (4) : Easy road paths, but not safe

1. Solav, 2. NW of Rawandouz,

3. Sartaq Bammu, and 4. Gulley Ali Beg

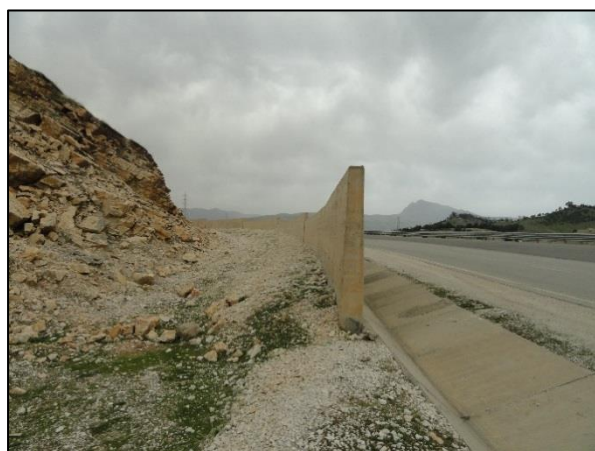
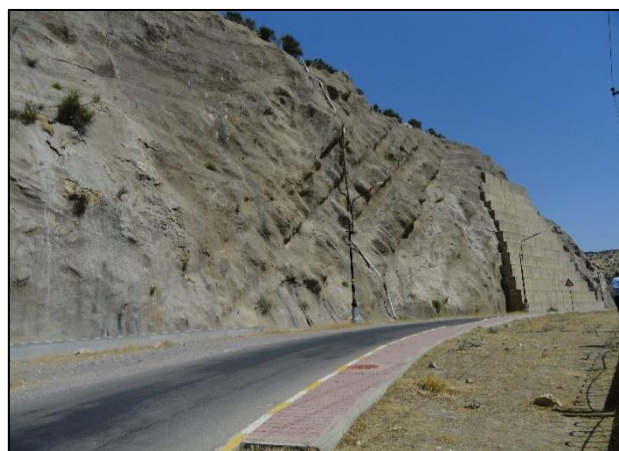
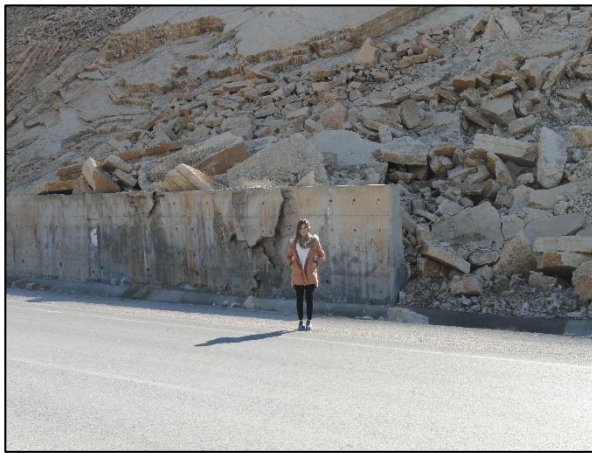
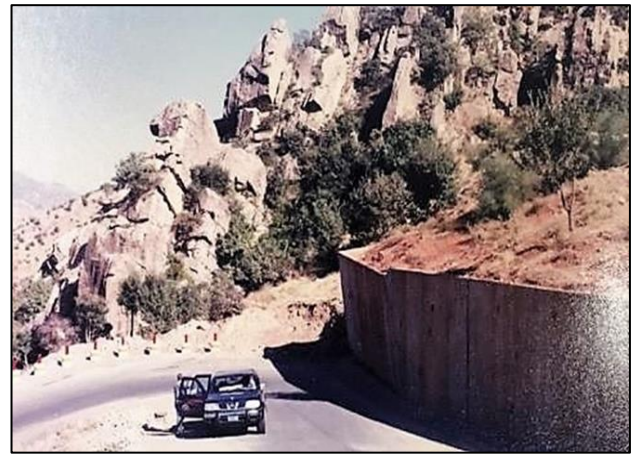
technology is used (Fig. 5, Top); even though some of the used aspects are not relevantly studied, designed and constructed (Fig. 5, Bottom). Accordingly, are damaged.

Fig (5) : Top, Left) Retaining wall facing unstable slope, Dukan – Surdash road, Top, Right) Retaining wall and shotcrete used in the treatment of unstable slope near Derbendikhan Dam. Bottom, Left) A damaged retaining wall, Dukan – Surdash road, Bottom, Right) Inclined retaining wall, along the road crossing Mateen Mountain

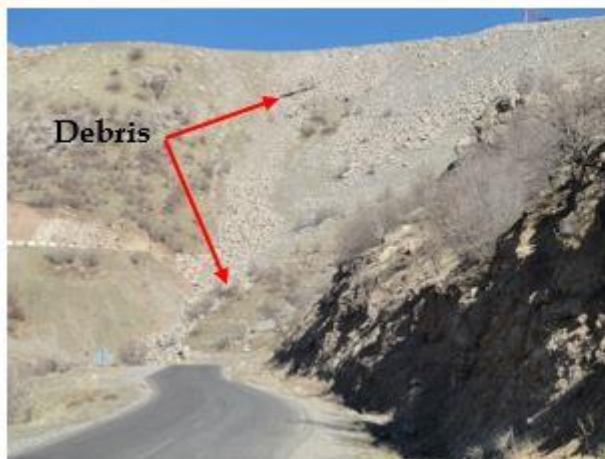
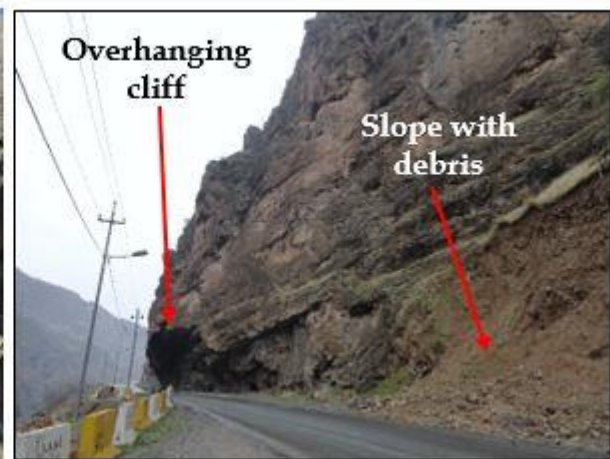
Fig (6) : Left) Road cut debris are dropped down slope without any treatment (Safeen road), Right) Overhanging cliff with slope full of debris (Gulley Ali Beg road)

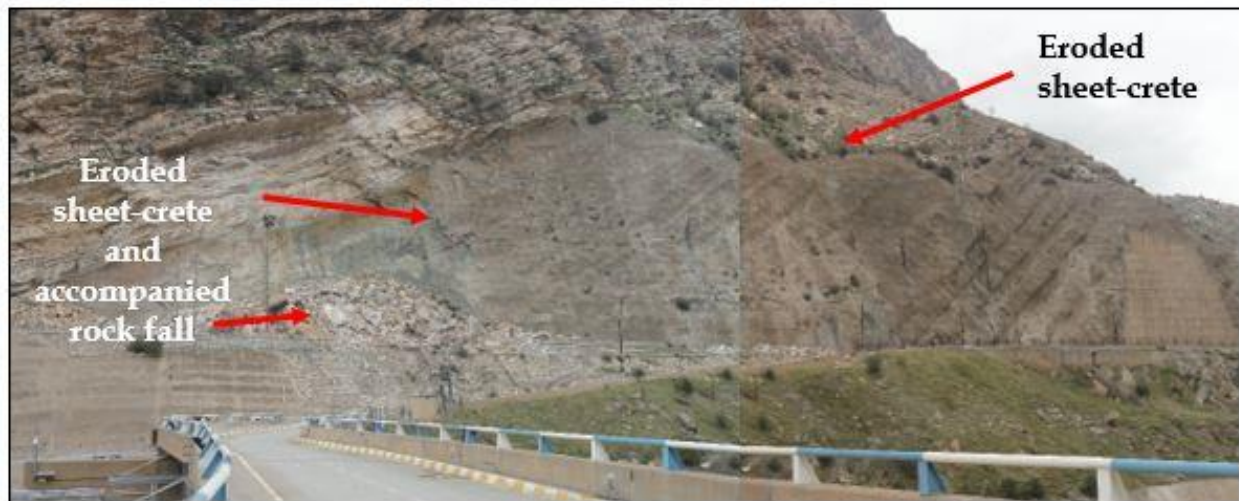
Fig (7) : A treated unstable road cut near Derbendikhan Dam. Note that the used sheet-crete is already damaged on the upper right side and the left side, it is accompanied by rock fall

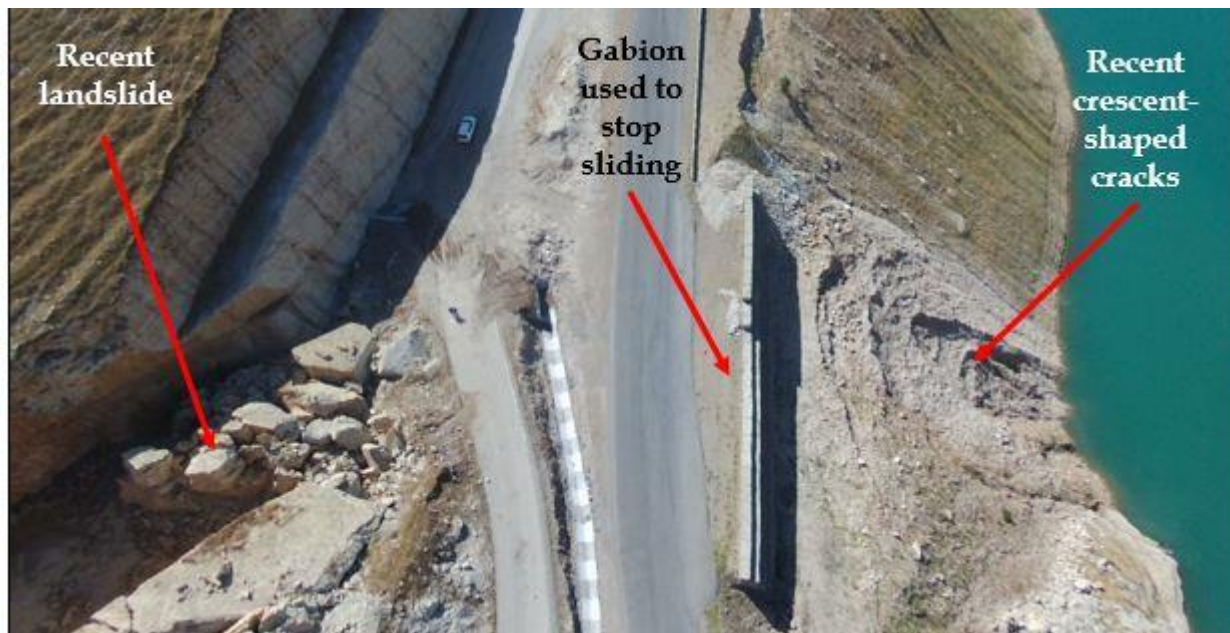
Fig (8) : Drawn photo showing bad treatment of a road cut that suffers from a landslide. Note the recent landslide, the used gabion and recently developed crescent-shaped cracks along the slope facing Derbendikhan lake
