The Role of Collaboration in Survey and Documentation of Historic Buildings. Case Study: Akre Historic Area in Kurdistan Region of Iraq

Shireen Younus Ismael ¹ and Bekas Jamaluddin Hasan ²

1 Department of Surveying, College of Engineering, University of Duhok, Duhok 42001, Kurdistan Region-Iraq

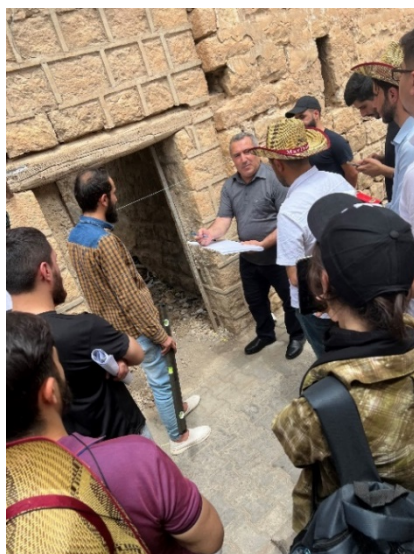
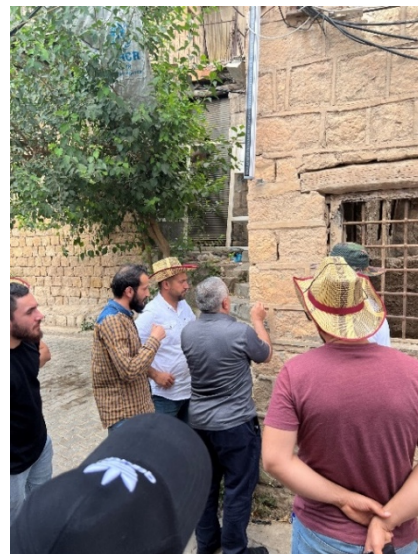
Figure 9: Training Group Members in Team 1 Using Hand Measurements and Theodolite

Two buildings (Jc14 and Jc67) were used as training grounds for this procedure, both in Zone c (Figure 9). An example of the descriptive data was explained for all the groups. Team 1 and Team 2 were not working in isolation; they instead exchanged information as data was collected (Figure 10), particularly since Team 2 collected data at a higher rate. For example; Team 2 had to inform Team 1 of any historic features they observed on a building (e.g., engravings, old text, any uncommon feature in the interior layout, old materials used in windows or doors, tunnels hidden in a historic building, etc.) so that Team 1 could prioritize these buildings in the drawing process. Another example was when both teams encountered houses that shared the same slab (2or 4 houses). These buildings were seen in the orthomosaic map as one building and thus were given a single code. Thus, when any group of Team 1 and Team 2 identified this feature, they would inform the other team to correct the numbering code of the houses. For example: Buildings with code: Jc105, Jc106, Jc 65 and Jc64 in Zone c are sharing the same roof.

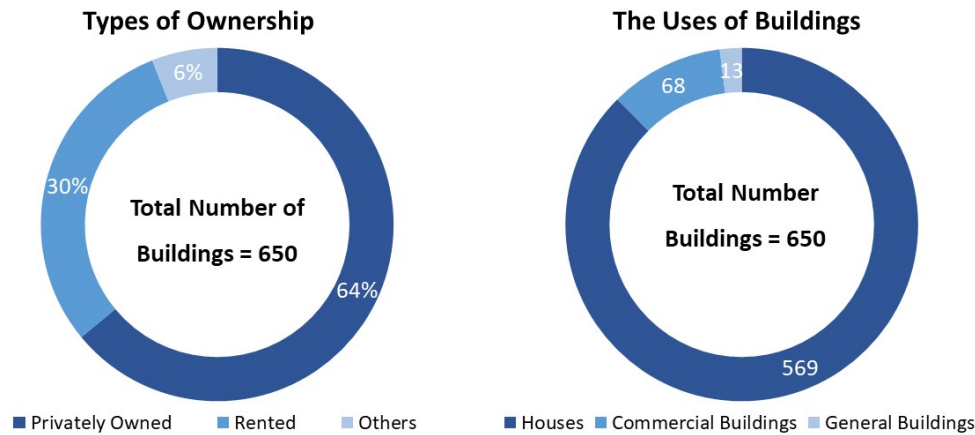
Figure 12: A: Ownership of Buildings in Study Area **Figure 12: B: Type of Uses of Buildings in Study Area**

One survey form was completed for each building. The data concluded that 1,727 inhabitants and 419 families live in the historic area. and 64% of the buildings were privately owned while 30% were rented (Figure 12 A).

The remaining 6% were unregistered in the Directorate of Real Estate Registry in Akre (TAPO). Among the 650 buildings in the historic area, 88% (569) are used for residential purposes, 10% (68) are commercial buildings, and 2% (13) are public buildings (Figure 12 B).

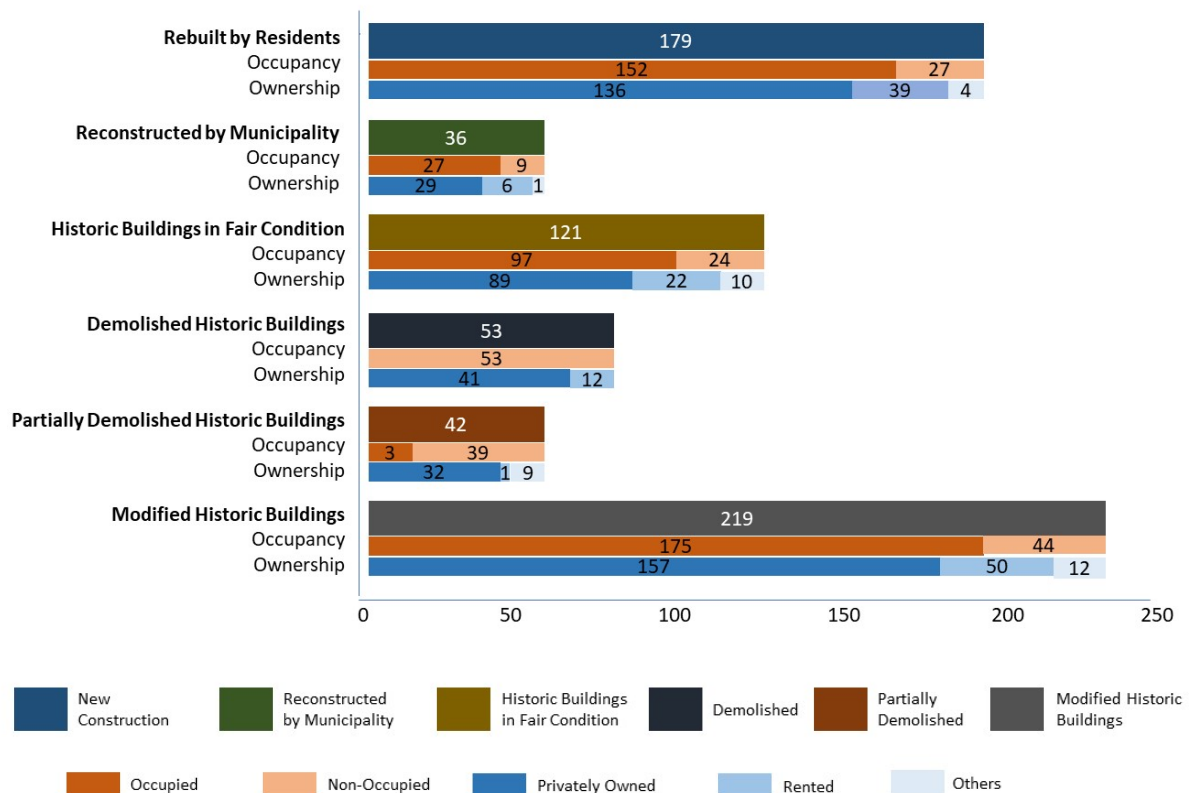
Figure 13: Buildings' Condition, Occupancy and Ownership Status in Akre Historic Area

Data from the site visit and the interviews held with the heads of households show that the highest category of the buildings was the modified which included 219 buildings; this highlights the need for alterations by many families, particularly due to extended families and many of these buildings required consolidation.

The second category in ranking was the rebuilt by residence, which included 179 buildings and involved changes with the massive amount occurring after 2005, as illustrated in the historic photos of the city.

The third largest category were the historic buildings in fair condition, consisting of 121 buildings, of which 97 are occupied (Figure 13).

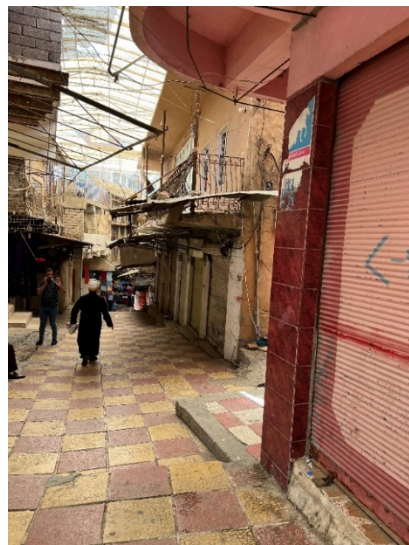
Figure 16: Old Bazar in Akre Historic Area

Meanwhile, 27% of respondents wanted to leave the historic area. Of those occupants, 65% mentioned the difficulty in mobility and in the transport of goods. This issue was prominently faced by the residents in zone a and b. another 17% cited lack of space in their houses. A further 9% whose houses are located near bazaar mentioned the noise in the historic area as the primary reason for the desire to leave. The remaining 9% did not define any reason for their desire to leave (Figure 15). During the interviews with the heads of households, almost all participants expressed urgency of having guidelines to be set by the government as they urgently need to renovate their houses. They also wanted to know about the government plans for the historic houses and whether the government would support them in maintaining their houses. Another important point highlighted by the residents including those who rebuilt their houses is an urgent need for the government to intervene regarding demolished and partially demolished houses as they pose a safety risk to nearby residents. Houses in the historic area cost considerably less than other areas mainly in the recent expansion of the city in terms of rent and sale. Buildings in the historic area can be sold for as low as \$5000 to \$40,000 per house. Monthly rent in this area can vary from \$40 to \$80 per house. The affordability of life in the historic area can be attributed primarily to the people's income, which stands at a monthly average of \$170. It is to be noted that the lowest monthly income in the historic area is \$100, while the highest is \$800. Additionally, the buildings located in the lower zones (such as g, e, and f) of the historic area cost more than houses in the higher zones (such as a and b), and the price difference between the historic houses and the renovated houses is negligible. The old bazaar of Akre contains 209 different businesses, in addition to another 82 businesses, which have been closed since last year due to low number of customers despite the low rent of the old bazaar shops relative to the newer areas of the city (Figure 16).

The majority of the closed businesses primarily sold local products. The failure of these businesses is an indicator of the lack of government effort in advancing the historic area as a tourist hotspot although the bazaar is around 300 m away from Sipa site (natural waterfall), a tourist natural hotspot visited by hundreds of thousands of people a year (Directorate of Statistics of Duhok Governorate, 2022). The current land use of the historic area is shown in the map in (Figure 17). Buildings illustrated in the map include one historic church crowning the historic area of the city at the top, eight mosques, one old hammam, one health center, the Qishla building dating back to Ottoman times, one primary school in the lower part of the historic area, the old bazaar at the bottom of the historic area which stretches mostly across Zone d, and small shops that are located across different zones. However, the dominant use of land in the historic area is housing. The smallest plot used for housing has an area of 32 m² while the largest plot has 300 m². Seventy-six percent of plots used for housing have an area of less than 100 m². In addition, the data shows historic area of Akre has an area of 32,1 Acres, and the population density is 54 inhabitants per acre, which is close to the high-density standard set by UN Habitat, which is 60 inhabitants per acre (UN HABITAT, 2014). Most of the open spaces in the historic area consist of steep natural terraces not suited for large gatherings of people. Plots holding historic buildings that have now become ruins are currently used for backyard farming by other households (Figure 17). Since Team 1 consists of four groups who were chosen from the seven zones of the historic area so each group can focus on one zone to prioritize buildings based on their historic potential to provide detailed drawings and descriptive data. The result of the data collected by the groups responsible for survey forms in Team 2 shows the number of buildings in each category of condition and in each zone (Table 1). The table shows that the most buildings with historic potential are in zone e, c, b, f, a, d, and g per the order of their numbers. The above data were triangulated with the data from previous knowledge of both researchers in the area, and the data from the purposeful site visit by all groups in Team 1 along with researchers. Selection of the data was based on criteria mentioned earlier in the methodology section. Zones a, b, c, and e were chosen. Zone a was chosen over Zone f despite the latter having more buildings with historic potential; this is primarily due to the buildings in Zone f being scattered further apart, while Zone a had buildings with important features individually and buildings clustered much closer together around the church.

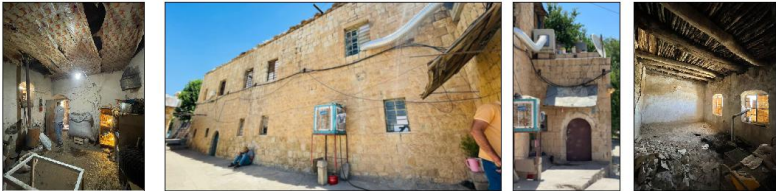
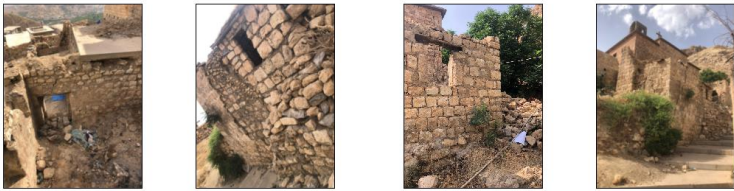
Table 2: Architectural Detail Drawings of Buildings with Historic Potential in Study Area in Zone a

B. CODE	PLAN	SECTION	ELEVATION
Ja 6 Ja 48

B. CODE	PLAN	SECTION	ELEVATION
Ga 24

However, the drawing data of 80 buildings reveal important features, both for individual buildings or groups of buildings that are mostly located in Zone c and e which are part of the Jewish neighborhood. The data show a diversity in typology, construction method, interior layout, and façade design, as well as different designs of arches of windows and doors, thus reflecting the Roman and Islamic influences in the architecture of the city throughout history.

Moreover, the data show the originality of the design and materials and diversity in plans and structure which all indicate adaptation to site constraints, particularly the limited space available in the hillside, with consideration of each building's view, thus resulting in the terrace form of the city. This terrace form is significant in that it is the only terrace character out of all the historic cities in Iraq. Tables 2, 3, 4 and 5 show the traditional architectural details of eight buildings, of which two were selected from each one of the four zones studied. These details include the building code, plans, elevations, sections, windows and door details, and photos. The architecture data of the studied buildings along with descriptive data would perfectly serve the determination of the importance of buildings by a rating system ranging from highest to lowest importance with a comparative analysis of similar buildings in the study area and the context.

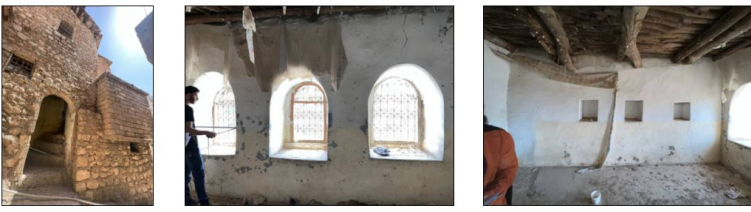
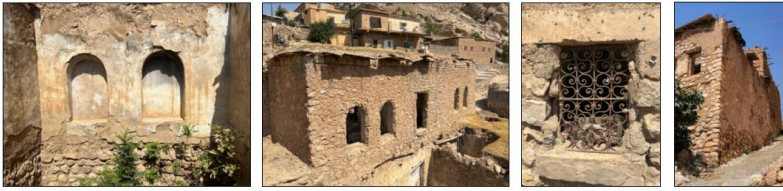
Table 3: Architectural Detail Drawings of Buildings with Historic Potential in Study Area in Zone b

B. CODE	PLAN	SECTION	ELEVATION
Gb 75

B. CODE	PLAN	SECTION	ELEVATION
Gb 117

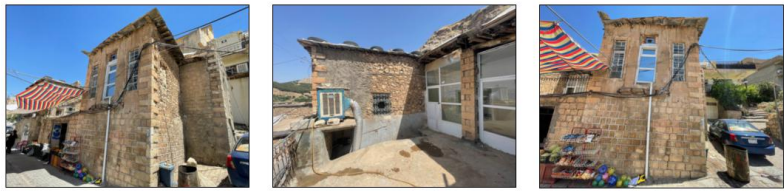
Table 4: Architectural Detail Drawings of Buildings with Historic Potential in Study Area in Zone c

B. CODE	PLAN	ELEVATION
Jc 67

B. CODE	PLAN		SECTION	ELEVATION
Jc 70

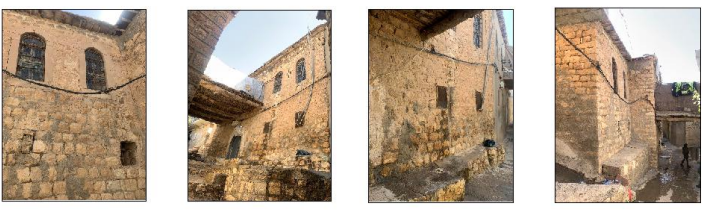
Table 5: Architectural Detail Drawings of Buildings with Historic Potential in Study Area in Zone e

B. CODE	PLAN		SECTION	ELEVATION
Je 15

B. CODE	PLAN		SECTION	ELEVATION
Je 101

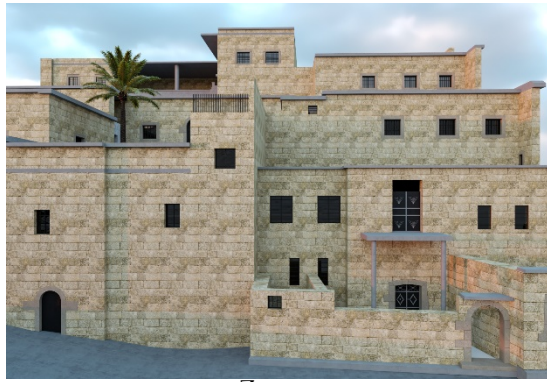
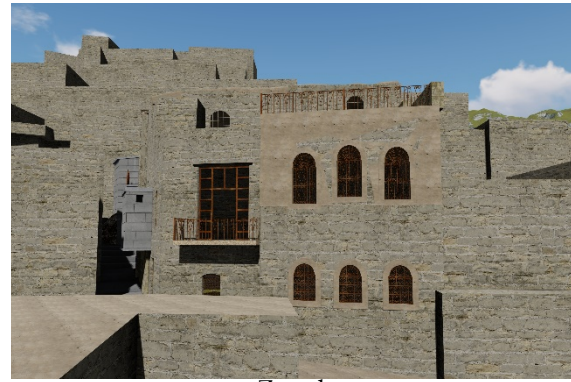
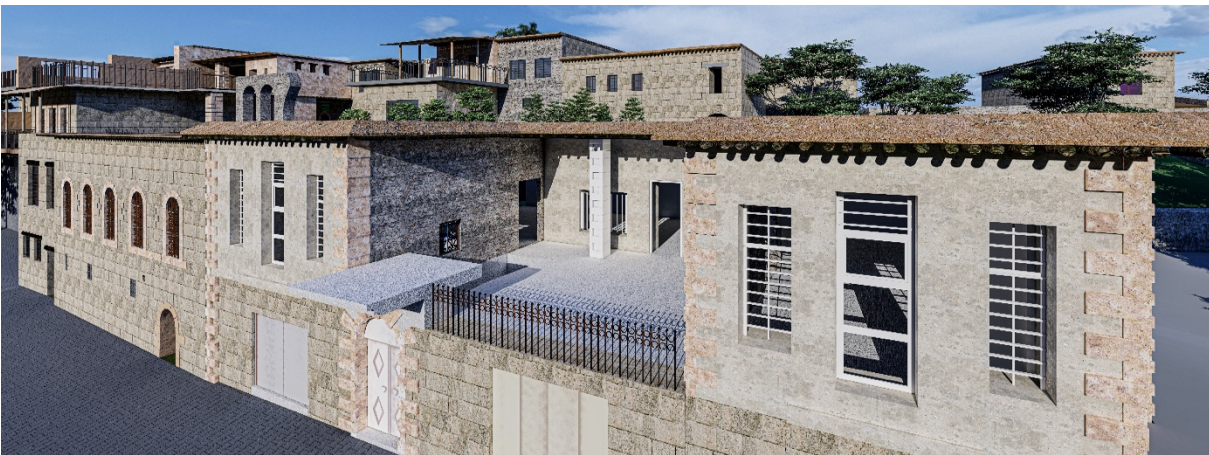
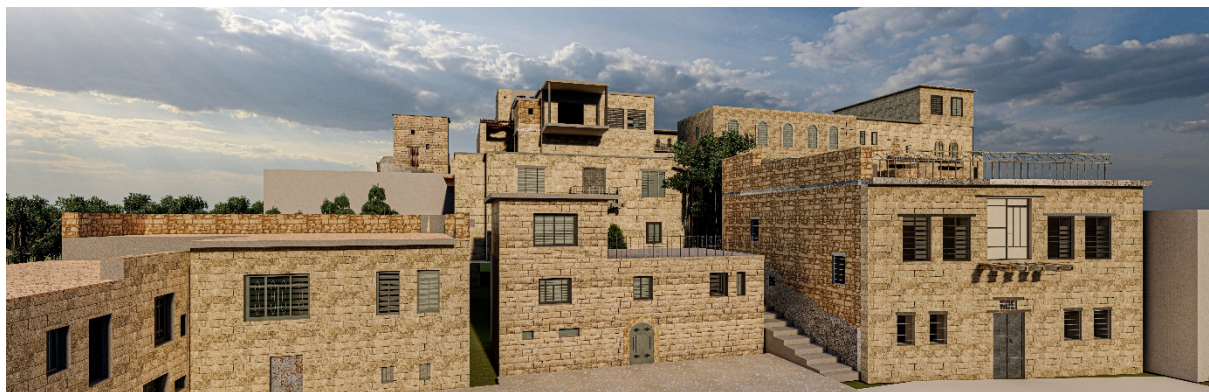
Figure 19: 3D Model of Group of Buildings in Different Zones in Akre Historic Area

Moreover, those data would help in designing the conservation plan of each building. Furthermore, the four examples of the 3D model of the group of buildings illustrated in Figure (19) could be used to set guidelines for preserving the traditional integrity of buildings represented in many features such as in the terrace form of the city. Another set of guidelines are needed to restore this feature in places where it has been lost, mostly in area where houses rebuilt by the residents and those reconstructed by the government are located. However, for the strategic plan with a heritage conservation vision, there is still a need for further collaboration efforts to collect data on the remaining important and deserved buildings.
